**DEPARTMENT OF TRANSPORTATION**

Quality Assurance and Source Inspection

Contract #: 04-0120F4Cty: SF/ALA Rte: 80 PM: 13.2/13.9File #: 69.28**WELDING INSPECTION REPORT****Resident Engineer:**Pursell, Gary**Address:** 333 Burma Road**City:** Oakland, CA 94607**Report No:** WIR-015735**Date Inspected:** 16-Jul-2010**Project Name:** SAS Superstructure**OSM Arrival Time:** 700**Prime Contractor:** American Bridge/Fluor Enterprises, a JV**OSM Departure Time:** 1900**Contractor:** Zhenhua Port Machinery Company, Ltd (ZPMC), Changxing Island **Location:** Shanghai, China

**Bridge No:** 34-0006**Component:** Tower & OBG Components**Summary of Items Observed:**

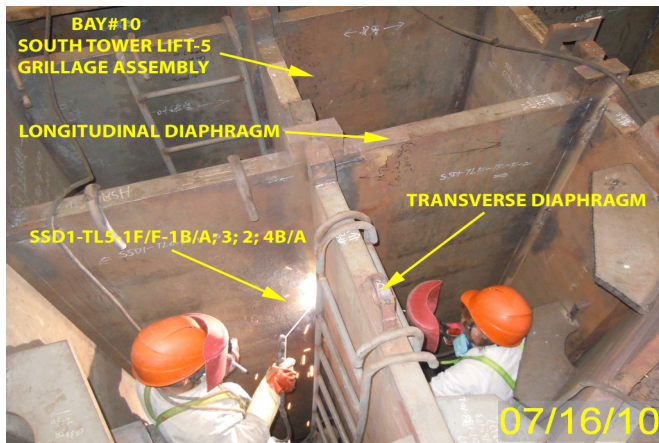
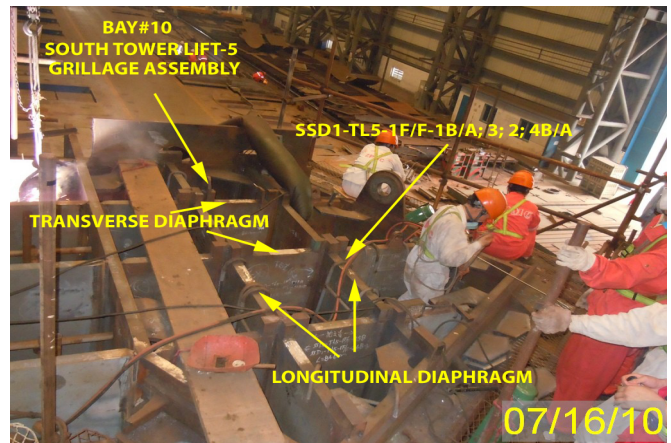
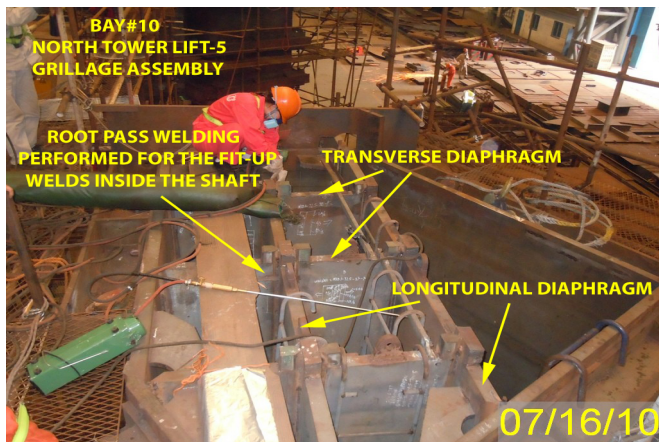
During the random in-process visual inspection on Lift-5 North and South Tower Shafts, this Quality Assurance Inspector (QA) discovered the following issue:

-On Lift-5 North and South Tower saddle Grillage assemblies; welding sequence followed by ZPMC is not as per the fabrication procedure.

-According to the detailed weld sequence, "First weld the grillage plate and face plate", "Then weld the joint between the grillage plates". Whereas ZPMC first started welding the joints between the grillage plates.

As per the Fabrication Procedure "Tower Saddle Grillage Fabrication, Assembly, Erection procedure"
